## **REDUCING THE FIRE HAZARD**

## **IN ALUMINUM-WIRED HOMES**

**Jesse Aronstein, PH.D., P.E.**

**Latest update: November 25, 2011**

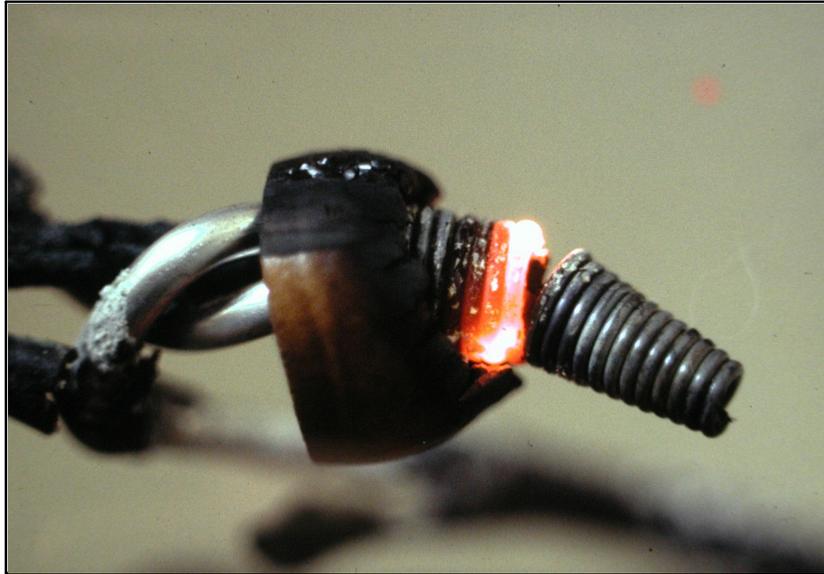
**FIGURE 1 - ALUMINUM WIRE SPLICES MADE WITH TWIST-ON CONNECTORS CAN BE DANGEROUS.** The use of most types of twist-on connectors with aluminum wire can lead to hazardous results. This twist-on pigtail connection (two #10 aluminum wires with one #12 copper wire, in a 20-amp circuit), made with a twist-on connector that was UL listed for use with aluminum wire at the time, remains electrically functional in the circuit, but it becomes extremely hot whenever a significant amount of current flows. The heat has deteriorated the insulation on both the connector and the wires. In this photo, a portion of the connector's spring is red hot, at current well below the circuit rating.

The most certain corrective action for all cases would be to rewire the home with copper wire. This is expensive and impractical in most cases. A practical approximation to rewiring can be achieved by a method known as "pigtail", using a specially-selected connector and installation method to splice a short length of solid copper wire to each aluminum wire end. The copper wire "pigtail" is then connected to the circuit breaker, light fixture, receptacle, appliance, or other termination. This method is effective provided that the connections between the aluminum wires and the copper pigtails are extremely reliable. Pigtail with some types of connectors, even though they might be presently listed by UL or certified by CSA for the application, may increase the hazard. [5][6] (See Figure 1.)

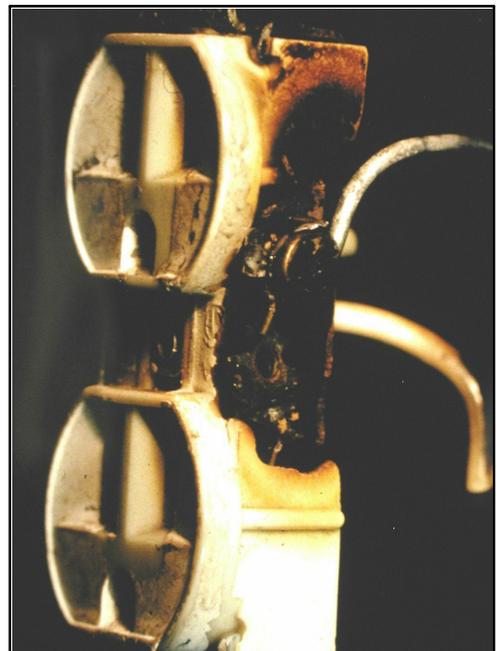
**FIGURE 2 - EXAMPLE: OVERHEATING OF ALUMINUM-WIRED TERMINALS ON A RECEPTACLE.** Enough heat was generated by current flowing through the aluminum wire connections to cause charring of the receptacle body and disintegration of the insulation that was on the wire. Note that the face of the receptacle, as the homeowner or an inspector would have seen it, with the cover plate on, would look normal.

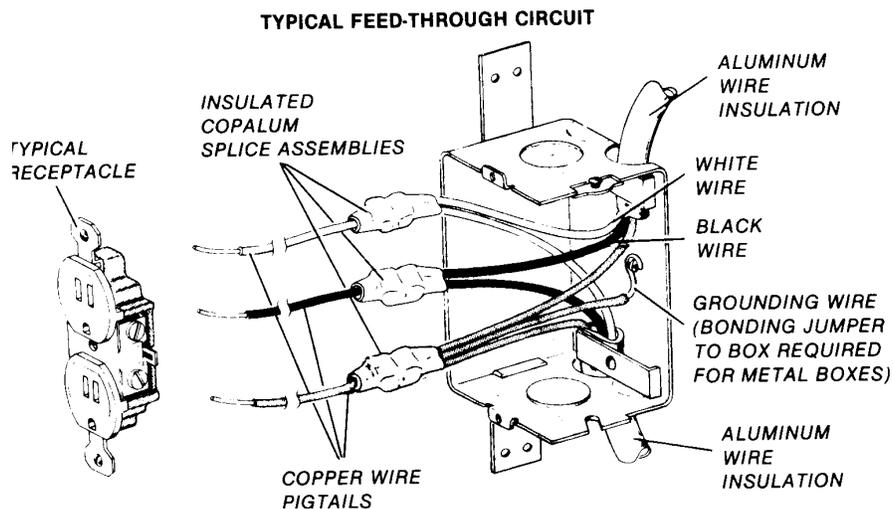
**FIGURE 3 - Illustration of copper wire pigtails spliced to aluminum circuit wires using COPALUM connectors (Source: CPSC)**

Repair by pigtailing, using COPALUM\* connectors installed by a qualified electrician, is considered by the U.S. Consumer Product Safety Commission ("CPSC") to be the best method for a permanent repair short of rewiring with copper.[7] Their recommendation is based on extensive testing and successful long-term field experience. The application of COPALUM connectors is considered to be satisfactory without special preparation of the aluminum conductor.

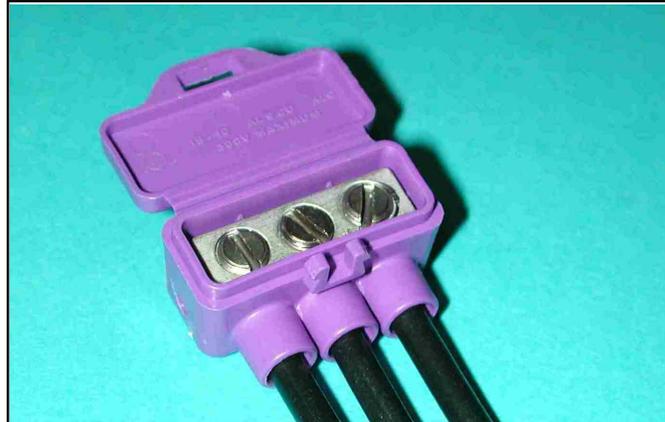
**FIGURE 4 - King Innovation "AlumiConn" Connector**

On the basis of the test results, the AlumiConn connector is predicted to have a high probability of failure-free long-term safe performance, *provided that the setscrews are carefully tightened according to the manufacturer's recommendation.*\* If not tightened to the manufacturer's recommendation, there is a possibility that the connections will degrade due to wire stresses and/or motion when the completed connection is manipulated into the outlet (or junction) box.

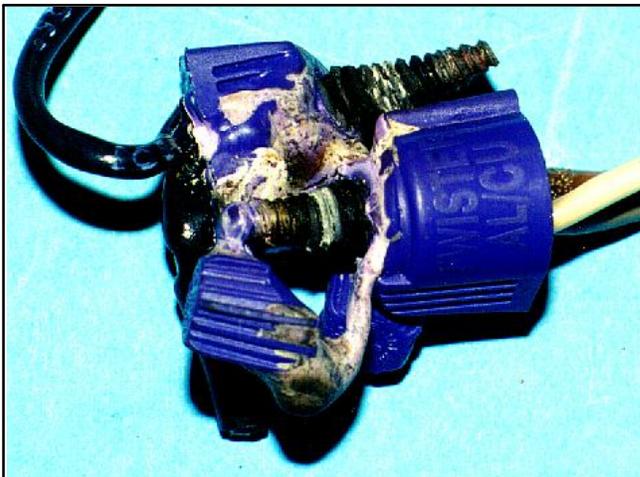
A. These two failed splices are adhered together by the melted plastic insulating shells.

**FIGURE 5 - FIELD FAILURES OF ALUMINUM TO COPPER SPLICES MADE WITH IDEAL #65 CONNECTORS [12]**

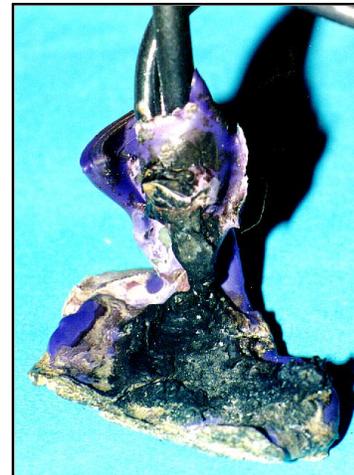
B. Severe failure, plastic shell melted and charred. The charring indicates that it had probably ignited.
