HAZARDOUS FPE CIRCUIT BREAKERS AND PANELS

Information for Inspectors and Homeowners

Prepared for the 17th Annual Spring Seminar, Feb. 21, 2004 St. Louis Chapter, American Society of Home Inspectors

J. ARONSTEIN

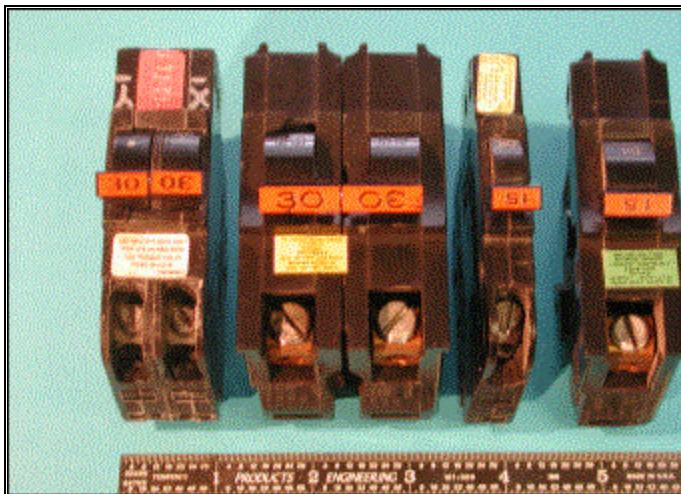
FIGURE 1 - HALF- AND FULL-WIDTH FPE STAB-LOK[®] CIRCUIT BREAKERS

(left to right: 1/2-width double pole, full-width double pole, 1 1/2-width single-pole, full width single-pole)

From an electrical safety standpoint, the most significant hazard identified in these CPSC-sponsored tests is that many of the two-pole FPE Stab-Lok[®] breakers may jam when trying to trip from overcurrent on one pole. This is due to mechanical friction in the common trip mechanism. Once the circuit breaker jams, its contacts will remain closed no matter what the current loading. This is serious -- a total failure that disables the protective device for that circuit. Essentially, the jammed breaker is exactly analogous to the "penny behind the fuse". This type of failure occurred in about 10% of the two-pole breakers.

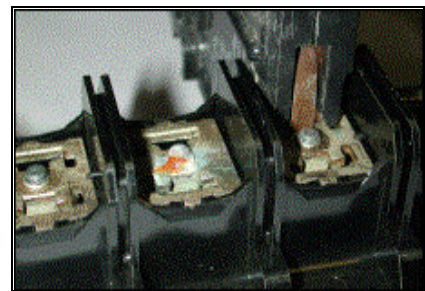
C. Stab socket on a post, attached with an 8-32 steel screw.

Of the three types illustrated, the one shown in Figure 2-C is known to have a high probability of

deteriorating and overheating of the stab socket structures when subjected to significant current flow. Each individual stab socket plate is connected to its bussbar via a post (spacer), and the assembly is held together by an 8-32 steel screw. FPE panels with this construction are prone to overheating failure. The five panels of the present study that showed evidence of serious overheating were constructed this way. One example is shown in Figure 3.

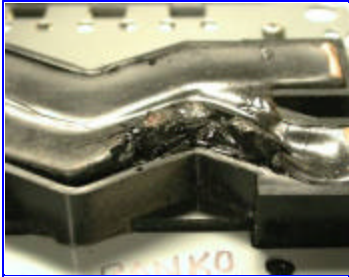
FIGURE 3 - OVERHEATING AT THE CONTACT BETWEEN THE BUSSBAR AND THE STAB SOCKET ASSEMBLY CAUSED THIS DAMAGE TO THE INSULATION. [\[Click for larger picture\]](#)

(This view is of the backside of the panel. The damage could not be seen unless the panel is taken out of the enclosure.)

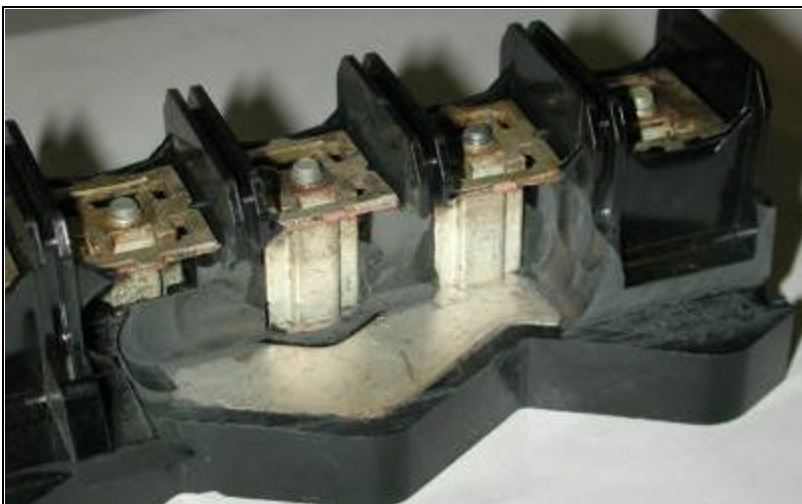
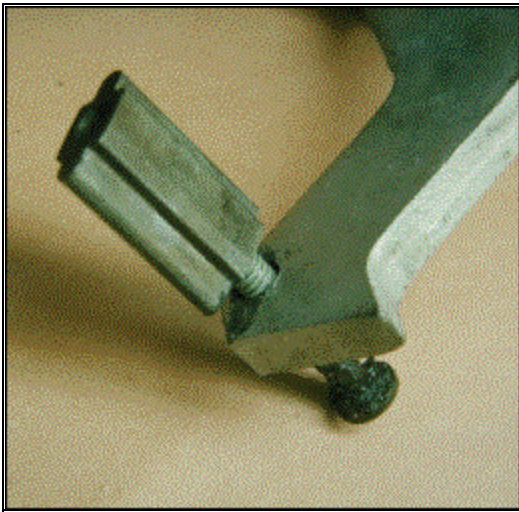
FIGURE 4 - CONDUCTING PATH FROM BUSSBAR TO STAB SOCKET PLATE

A. Cutaway - Bussbar, Post, and Stab Socket Plate.

B. Bussbar, Screw, and Post

Various material combinations were utilized by FPE in these assemblies. Some bussbars are copper, others are aluminum. Some posts are copper, others are aluminum. The worst case (most likely to fail) is where both the bussbar and the post are made of aluminum, and the best case (least likely to fail) is where both are made of copper. Inspectors (or homeowners, or electricians) have no way of knowing which materials are utilized in any particular FPE panel with this type of construction.

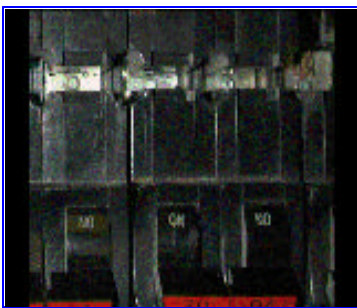
Inspectors can, however, determine if a particular FPE panel has this type of construction, and, to a limited extent, whether it has failing bussbar interconnections that have previously overheated. With the panel cover off, for this type of panel, you can see the screws holding the stab socket plate, as shown in Figure 5. The stab socket plates and the visible ends of the screws should have a bright metallic look. Darkening, discoloration, or signs of corrosion most likely indicate past episodes of abnormal heating.

FIGURE 5 - THE ENDS OF THE SCREWS HOLDING THE STAB SOCKET PLATES ARE VISIBLE BETWEEN THE TWO ROWS OF BREAKERS. THIS IDENTIFIES IT AS A PANEL OF THE TYPE SHOWN IN FIGURE 2-C [\[Click for larger image\]](#)

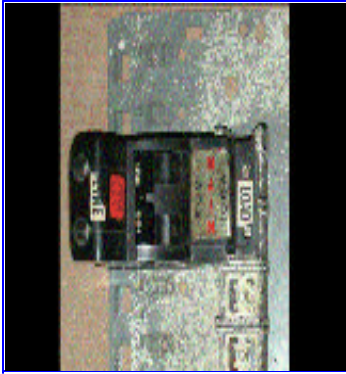
the main breaker terminals are size 8-32, which is absurdly small for clamping the terminals of a 100-amp main breaker.

FIGURE 6 - FPE 100-AMP MAIN BREAKER CONNECTS TO THE BUSSBARS THROUGH THE PLATE & POST CONFIGURATION, USING ONE 8-32 SCREW AT EACH TERMINAL.

(The heads of the 8-32 terminal clamping screws are seen above and below the "LOAD" label.)

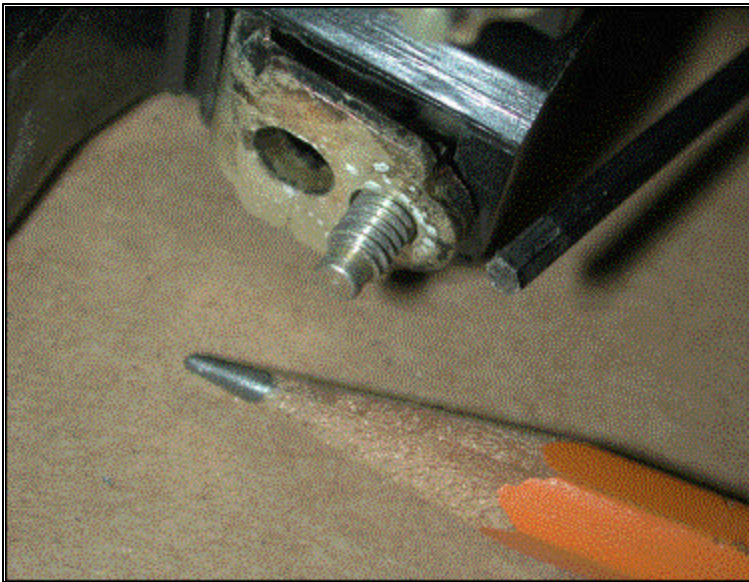
FIGURE 7 - ONE LOAD-SIDE CONTACT AND ITS 8-32 CLAMPING SCREW, ON THE FPE 100-AMP MAIN BREAKER OF FIG. 6. THE SCREW-HEAD TAKES A 3/32" ALLEN WRENCH, WHICH IS ONLY SLIGHTLY LARGER THAN THE LEAD OF THE #2 PENCIL.

(The larger hole provides clearance for the screw protruding from the stab contact plate)

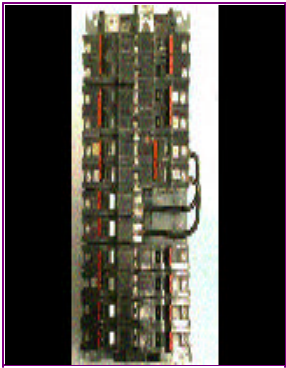
FIGURE 8 - FPE STAB-LOK[®] "RULE-OF-SIX" (SPLIT-BUS) PANEL WITH NO MAIN BREAKER. THE JUMPER CABLES ON THE RIGHT SIDE FEED THE LOWER SECTION.

There are many different design variations, but the essential element is that in these "rule of six" panels there is no main breaker, and, typically, the lower section of the panel is fed from jumpers coming from the output of one of up to six double-pole breakers in the upper section. The FPE Stab-Lok[®] double pole breakers have a relatively high probability of jamming when called on to trip, however, as previously demonstrated by the test results presented in Section 1. That means that the home with an FPE "rule-of-six" panel has an unacceptably high probability of having one or more circuits that are totally unprotected, in which the maximum current flow is only limited by what the transformer on the pole can deliver. This is likely to be of the order of 1,000 Amps or more.

On first glance, the FPE Stab-Lok[®] panel previously shown in Figure 8 looks normal. In fact, however, it clearly demonstrates several of the hazardous failure modes discussed in the previous sections. It is one of 17 collected for the recent testing. It is from a home built in 1974, whose new owners had determined in 1999 that it should be replaced. Their decision to replace it was in part prompted by information available on the internet regarding FPE breaker problems.⁷ According to the homeowner, who sent it to me for examination and testing, *"We recently had it replaced and found the breaker to the dryer fried in just the way described. Our electrician was astonished. Two others we had bids from dismissed our concerns with contempt."*⁸

There is no question but that the FPE STAB-LOK[®] panels should be replaced. There is no practical and safe alternative.

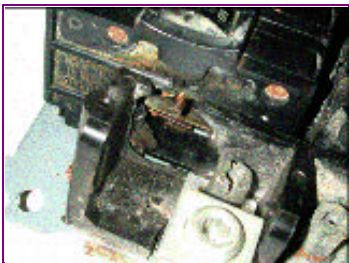
The main service cable connector has been rotated out of the way for better visibility of the damage. The plastic insulator is burnt and cracked. The breaker's internal mechanism can be seen through the hole burned through its side. Figures 10 and 11 show the damage to the separate items.

FIGURE 9 - VIEW DOWN TOWARD UPPER RIGHT OF PANEL SHOWN IN FIG. 8.
THE FPE STAB-LOK[®] TWO-POLE 30-AMP BREAKER FED THE CLOTHES DRYER. [\[Click for larger image\]](#)

The damage to the breaker is exactly as had been demonstrated in the tests done for CPSC.^{2, 3, 4} Those tests demonstrated that, when an FPE breaker jammed and the current exceeded about 300% of the breaker's rating, the side of the breaker disintegrated and/or ignited from the heat being generated within the breaker. This is due to resistive heating of the breaker's internal current-carrying components, mainly the bimetal element and the flexible copper braid that connects to it. This is not an arcing failure, although the damage to the insulating materials of the breaker and panel sets the stage for an arcing fault to occur.
