Washing Machine Hoses: A Disaster Waiting to Happen

Why and How Do Washing Machine Hoses Fail?

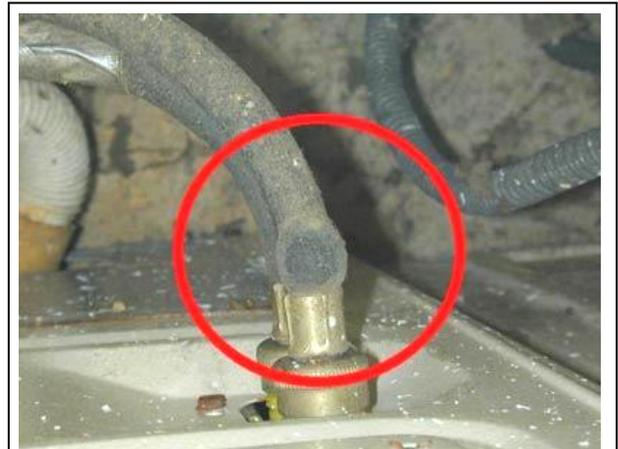
Fig. 1. Standard rubber washing machine hose about to burst.

Most traditional washing machine hoses are made of reinforced rubber or polymer. (Fig. 1) These materials lose resiliency as they age, making them subject to cracks, leaks, and bursting. The IBHS study showed that failure rates increase dramatically in hoses that are more than five years old; the average age of failed hoses was 8.7 years. More than half of all failures occurred by the time the machine and its hoses were eight years old, and nearly 80% occurred before ten years.

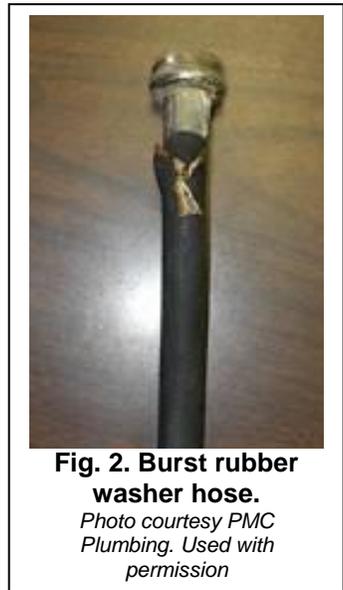
Fig. 2. Burst rubber washer hose.

Standard black washer hoses are made of rubber tubing with a polyester reinforcement lining. (Fig. 3) The metal inserts at the coupling end are rolled and stamped from thin sheets of copper alloy. Most failures occur at the end of the hose, where the metal insert comes into contact with the tubing. (Fig. 2) Failures generally occur for one of the following reasons:

Razoring — The metal insert has a very sharp edge which is in direct contact with the rubber tube. This edge becomes progressively thinner and sharper as it is worn away by the movements of the water and by the effects of electrolysis. In a process called “razoring,” the motion of the washing machine causes the metal edge to rub repeatedly against the inside of the hose, cutting it gradually from the inside out.

Stress Fractures — The metal insert is attached to the hose by a ferrule, or ring, which is crimped tightly to hold the pieces together. The crimping can cause a stress fracture in the hose, which is then subject to failure, especially as the rubber ages and begins to deteriorate.

Rusting — Corrosion (rusting) of the metal fitting can cause failure in two ways. First, as the thin metal fitting corrodes, it becomes jagged and rough and cuts into the hose as the washing machine operates. Water can leak between the hose and its outer covering, forming a bubble, a critical warning sign of imminent failure. (Fig. 1) Though a bubble may appear anywhere along the line, most breaks occur at the point where the metal fitting meets the rubber tube. Second, as the fitting continues to corrode, it can become so weak that it may eventually break apart.

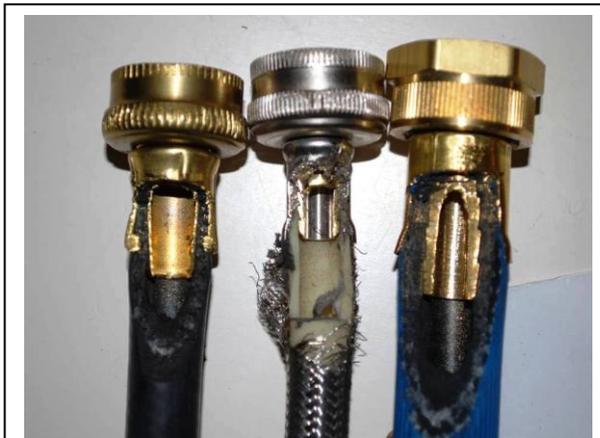
Fig. 3. Left to right: Cross sections of a standard black rubber hose, a plastic hose with braided stainless steel covering, and the Floodchek™ hose.

Crimping — A braided stainless steel hose consists of a plastic or rubber tube covered with a braided steel sheath, which is sometimes protected with a thin nylon coating. (Fig. 3) Because of the variety of materials used, a very tight crimp is required to fasten the metal fitting securely to the hose. During the manufacturing process, this tight crimping can damage the hose by cutting into the rubber. Once the product is installed on a washing machine, the action of the water and the movements of the machine can make the cuts worse, leading to eventual failure.

For best results, Sequoia Insurance recommends that all washing machines be fitted with heavy-duty engineered hoses such as Floodchek™ (Fig. 3) rather than with standard black hoses or braided steel hoses.

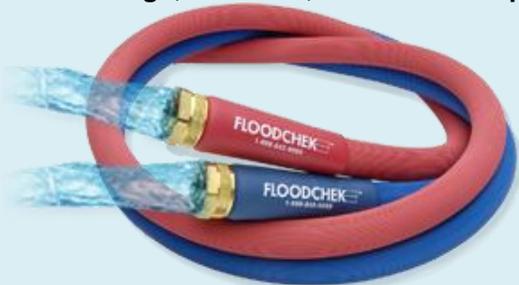
The Floodchek hose features a sturdy brass insert that is rounded at the end to prevent its cutting the hose from the inside. And because the brass is thicker, the fitting can withstand crimping along the whole length of the insert, which allows the pressure of the crimp to be distributed over a larger area, thus preventing a single pressure point that can damage the hose. The hose is flared at the fitting end, providing ample space around the end of the insert, which also reduces the risk of damage inside the hose. The Floodchek hose is twice as thick as conventional hoses and is extra sturdy for long wear. The use of better-quality brass discourages electrolysis. According to Floodchek, there has not yet been a single reported failure of Floodchek hose in the tens of thousands of installations done since 1989. More information is at www.floodchek.com.
