Overview

Most Federal Pacific (FPE) Stab-lok[®] circuit breakers and panels manufactured before 1980 are thought to be defective. Industry experts report that they are very likely to fail to trip when needed during current overload and short circuit situations, creating a very high risk of fire.

Performance History of FPE Stab-lok[®] Circuit Breakers

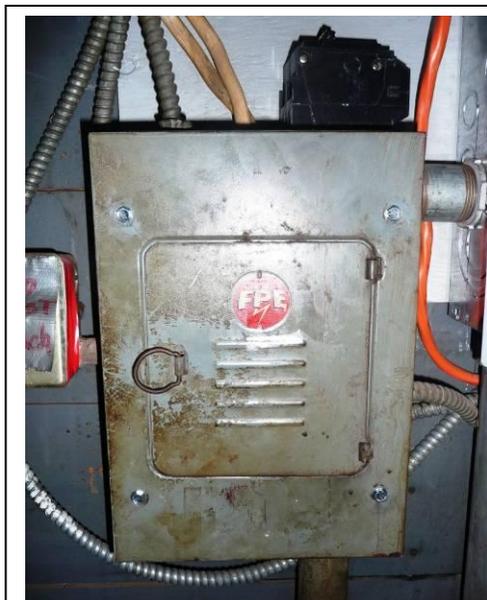
**Fig. 1. FPE Stab-lok®
Small Panel Box**

FPE Stab-lok® products are labeled with various brand names, depending on when they were manufactured and where they were distributed. Look for labels on the outside of the breaker panel box; if there are none, open the door and look inside the cover (Figures 1, 2, and 3).

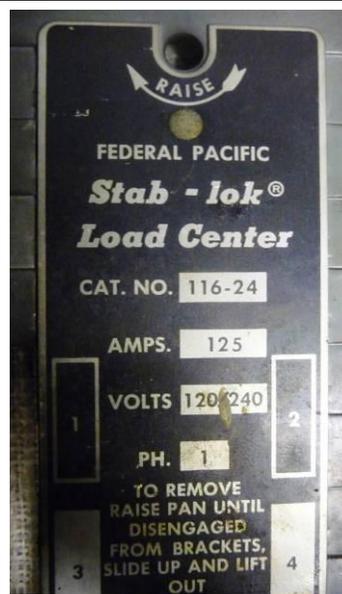
**Fig. 2. FPE Stab-lok®
Panel ID Plate**

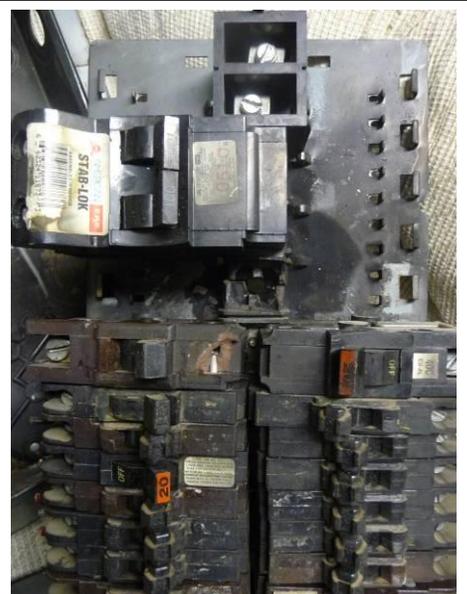
Fig. 3. Stab-lok® Breakers

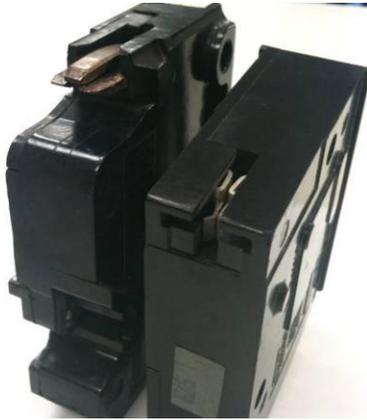
Fig. 4. Stab-lok® and Conventional Breakers

The components of well-designed circuit breakers fit together firmly and precisely. Most breaker switches have a set of jaws that fit over the bus bar so that the metal of the jaw is held parallel to the bus bar.

The FPE Stab-lok® breaker has an opposite type of design, with prongs that fit into slots in the bus bar, bringing the two pieces of metal into contact only at their edges, where they touch at a right angle. This precarious connection, which creates a very small contact area, can fail to maintain sufficient contact pressure between the components, which easily can become loose. (Figures 4, 5, 6)

This combination of small contact area, minimal contact pressure, and spontaneous loosening can cause arcing and over-heating, particularly when the circuit is overloaded or approaching overload. Arcing and over-heating can, in turn, cause fires.

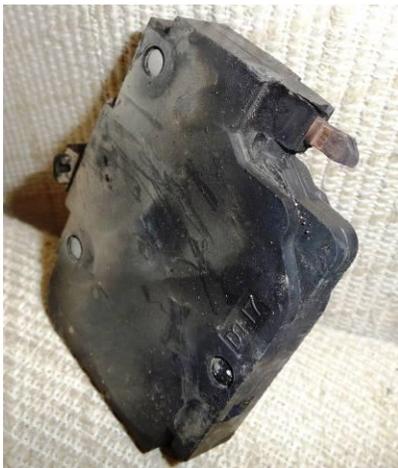
Fig. 5. 15 amp Stab-lok® Breaker (Note Smaller Connection Point)

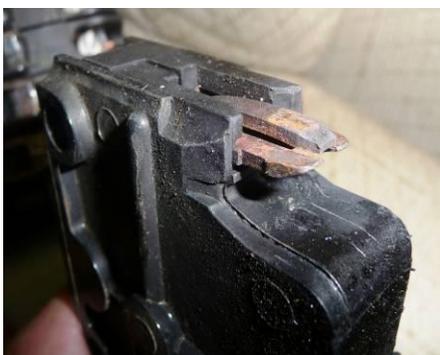
Fig. 6. 20-amp Stab-lok® Breaker (Note Connection Points)

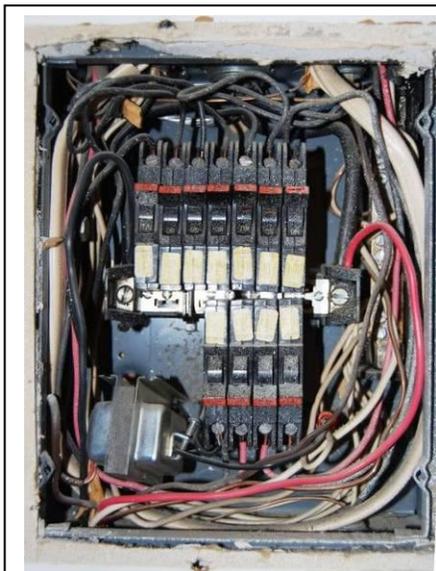
Even when standards were revised in 1981, near the time when Federal Pacific ceased manufacture of Stab-lok® panels, FPE found ways to use less space (thereby reducing costs) by installing components at unconventional angles and bending the wires too sharply within the panel space (Figure 7).

Fig. 7. Stab-lok® Circuit Box
Photo courtesy John Naehring, ©2009.
Used with permission.

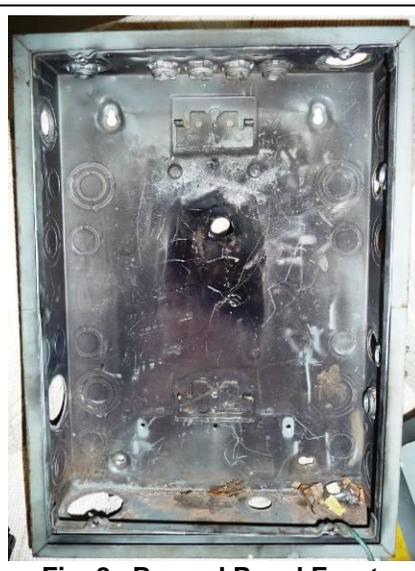
Fig. 8. Burned Panel Front
Photo courtesy SCM Engineering, © 2012.
Used with permission.

Obvious signs of overheating (scorch marks, burns, darkened or discolored areas, soot inside the case, melted parts or insulation) indicate that the breakers are not functioning properly and that the situation is imminently hazardous. Figures 8 and 9 show an FPE panel where a breaker malfunction burned a hole through the metal panel box and into the wall.

Consider Replacing the Circuit Breaker Panel. One option is to replace the entire circuit breaker panel with all-new equipment; this may be the safest, easiest, and most cost-effective solution for properties where FPE Stab-lok® circuit breakers and boxes are still in operation, and it is recommended by most electricians. (Figure 12.) However, your electrician may suggest other courses of action.

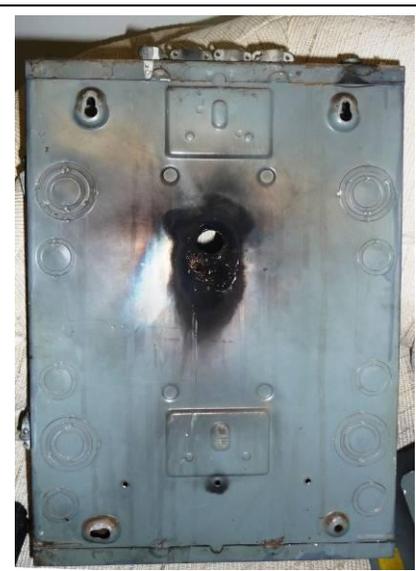
Fig. 9. Burned Panel Rear
Photo courtesy SCM Engineering, © 2012.
Used with permission.

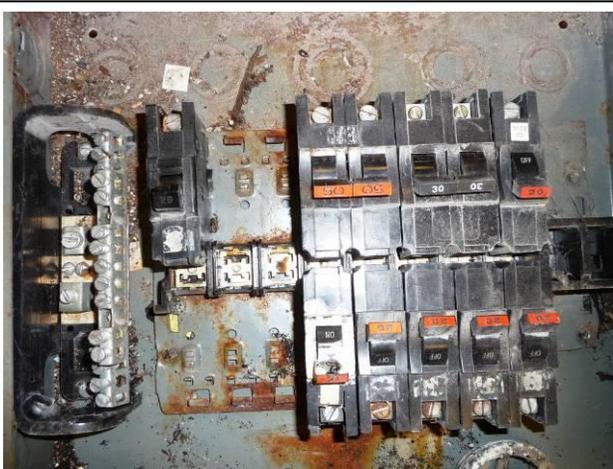
Fig. 10. Corrosion and “Burn” Marks on a Stab-lok Panel

Other warning signs that can indicate hazardous conditions that may precede a failure of the breakers and other components may include corrosion or oxidation; poor contacts between components; humming, buzzing, popping, cracking,

other abnormal sounds; or strange odors. (Figures 10 and 11)

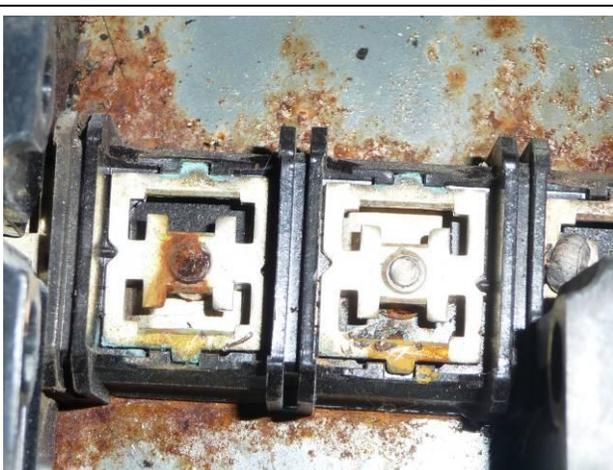
Fig. 11. Close-Up of Corrosion and “Burn” Marks on a Stab-lok Panel

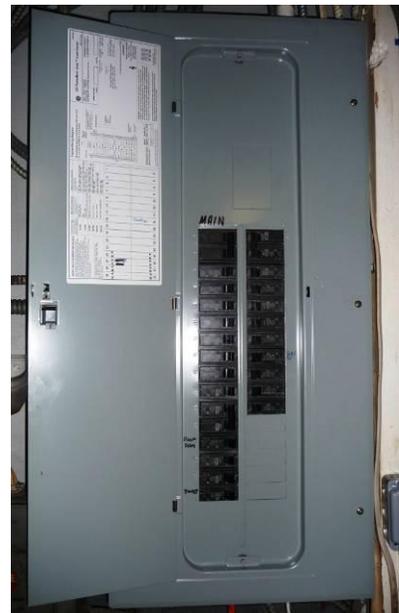
Fig. 12. New Replacement Panel
*Photo courtesy SCM Engineering, © 2012.
Used with permission.*

- Do not use "refurbished" or "replacement" FPE Stab-lok® breakers; many of these are salvaged and not safe to use.
- Do not use "new old stock," which is the same as the product that needs to be replaced. *Use only new UL-listed equipment from a reliable manufacturer.*
