## COMPOSITION SHINGLE ROOFING - PICTORIAL

### 2.1 Effects of Weathering

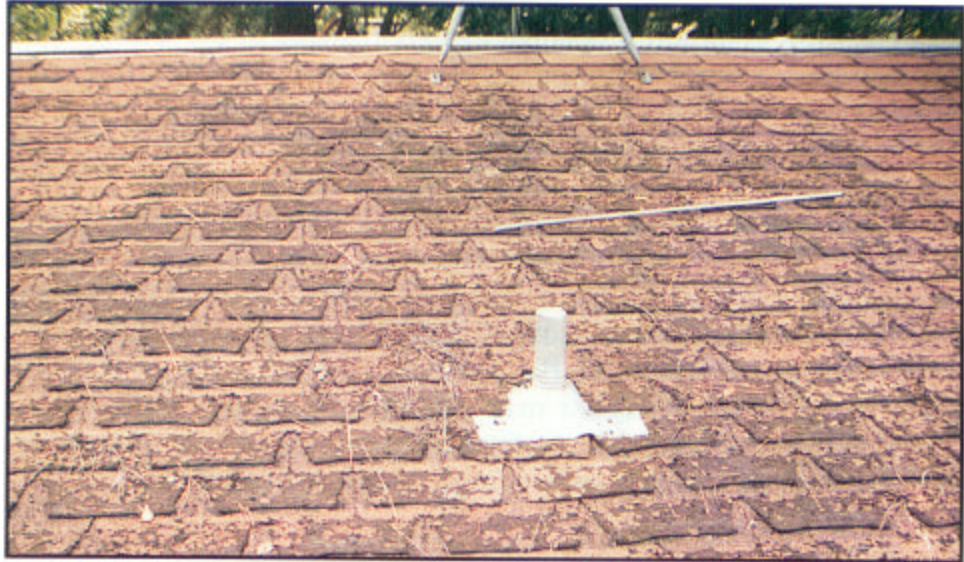
Photo 2.1.1 Weathering occurs when composition shingles are exposed to the elements. The originally rectangular tabs become trapezoidal as the asphalt becomes brittle and shrinks.

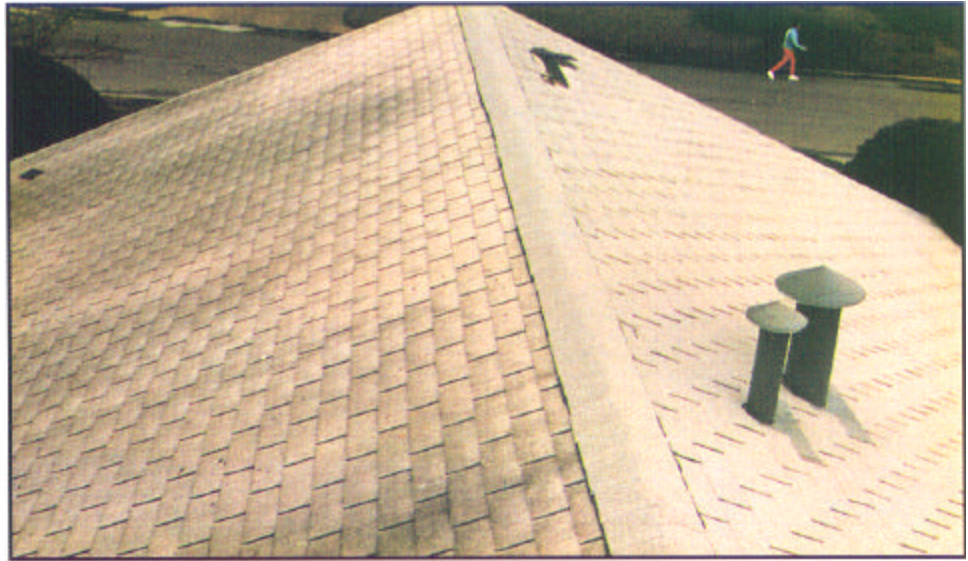
Photo 2.1.5 The most severe exposure is the southern. On this roof, the southern exposure (the right slope in the photo) had been replaced far in advance of the northern slope. Dark colored patches on the northern slope are algae that enjoy the moisture of the more sheltered exposure. Remember that each roof slope ages (or weathers) at a different rate due to its exposure.

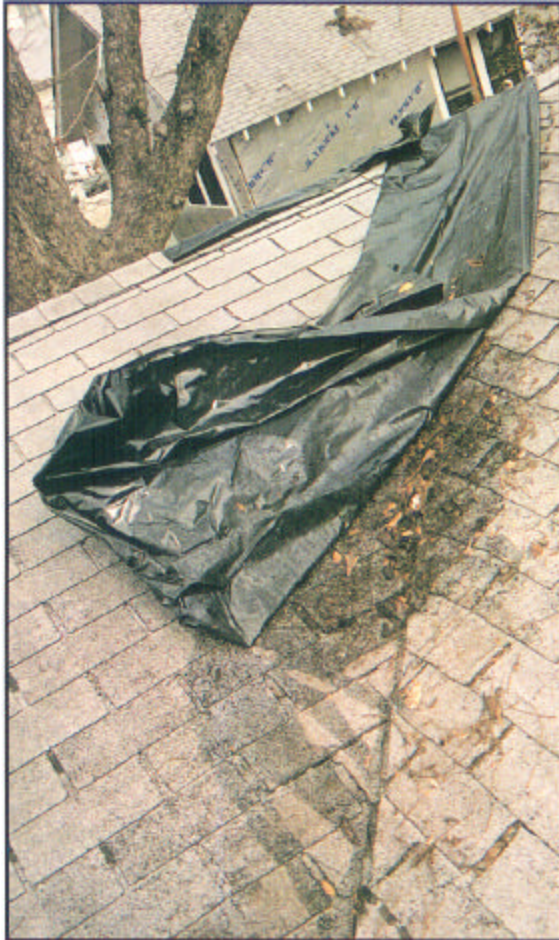
Photo 2.1.7 Organic debris promotes algae growth since it harbors moisture.

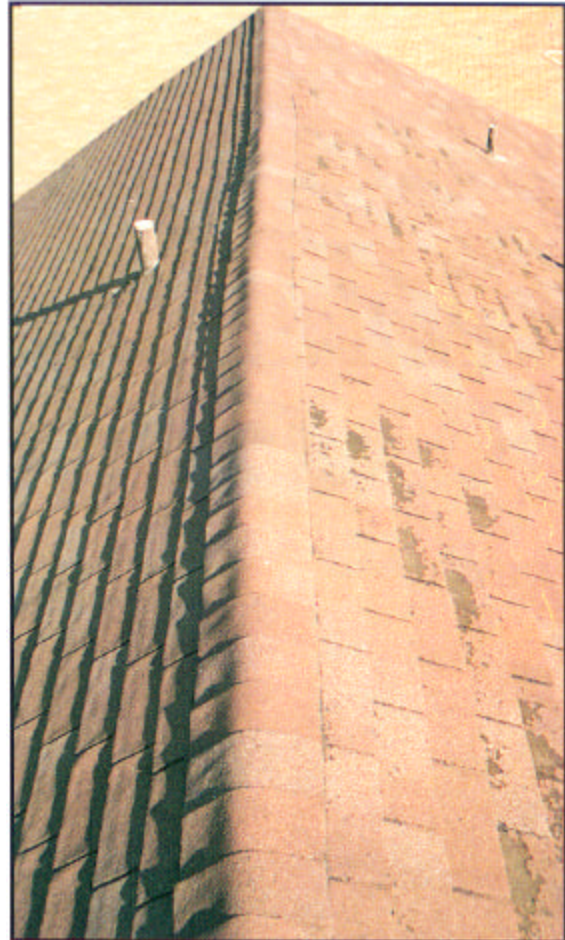
Photo 2.1.8 Shingles on these slopes are the same age; the attic space beneath the right slope was not vented (cathedral ceiling construction) whereas the attic space on the left was vented. Inadequate venting intensifies exposure effects by increasing roof material temperatures and accelerating the composition shingle aging process.

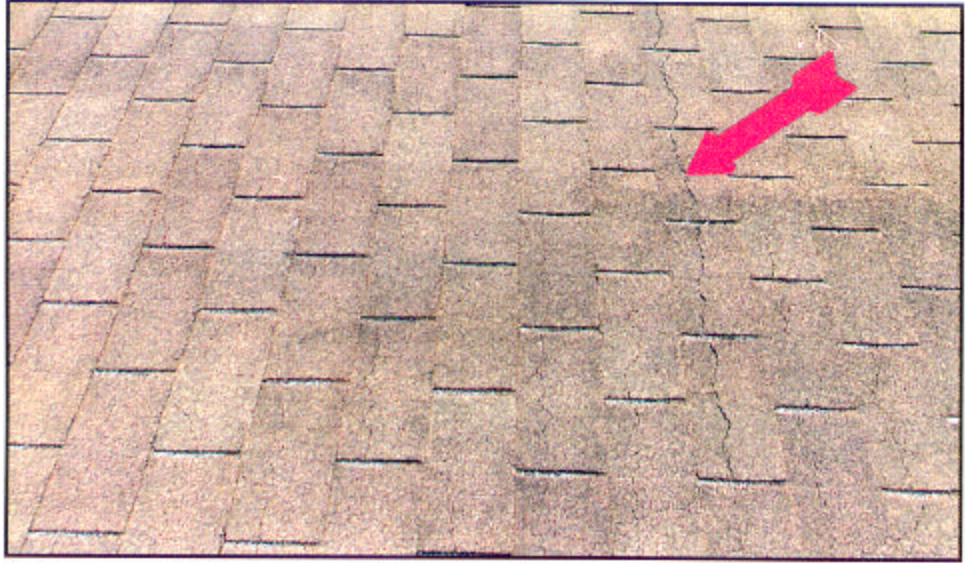
Photo 2.1.9 Look closely to see horizontal cracks traversing the composition shingle tabs in this photo. Recall that each tab is fastened above by mechanical fasteners and below by self-sealing adhesive strips. Thermally induced strains have fractured the tabs, separating them from tops of the shingles at the line of least resistance.

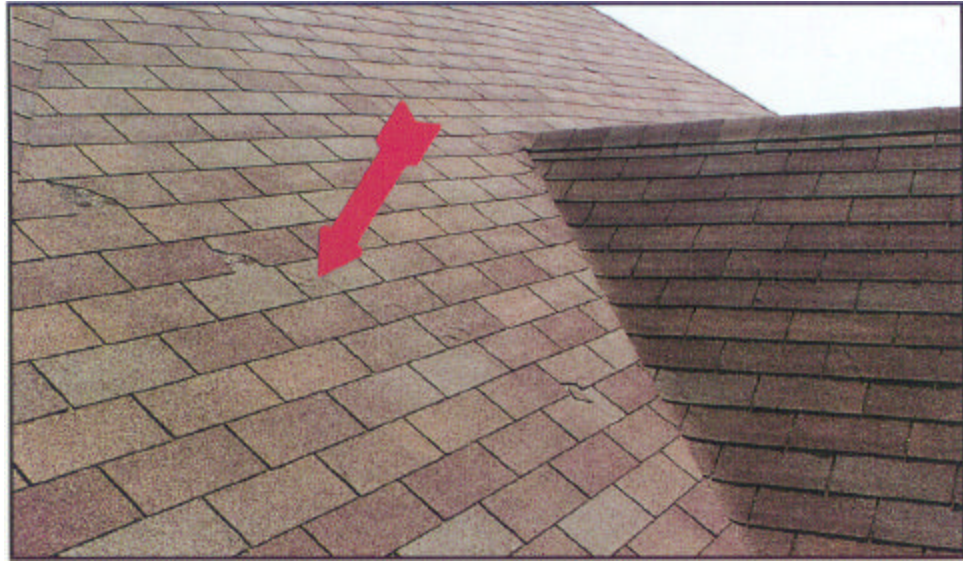
Photo 2.1.11 Decking distortions typically due to temperature and/or moisture can cause diagonal tears in the shingles, as on the slope of this roof. Severe foundation settlement problems also can cause such diagonal tearing.

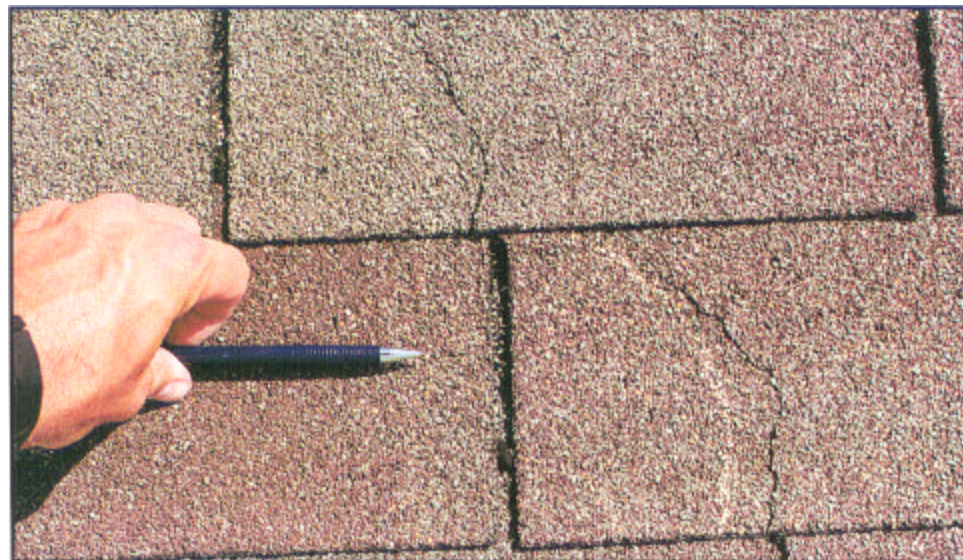
Photo 2.1.12 In this close-up, we see a diagonal tear (induced by underlying deck movements) traversing the roof slope from bottom right to top left.

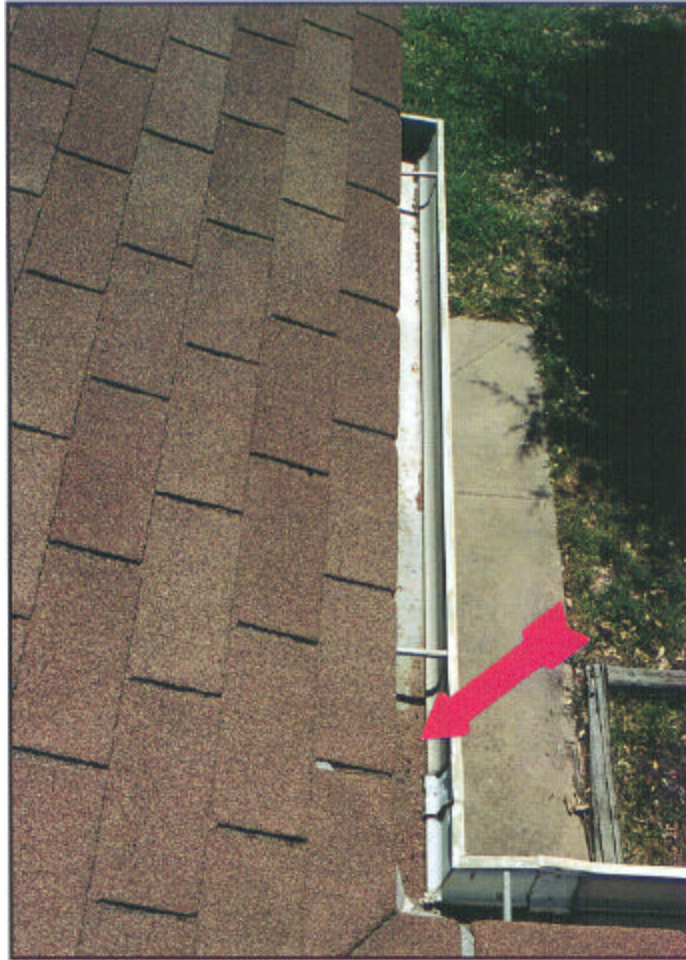
Photo 2.1.13 Close-up of composition shingle granules collected in gutter along roof eave.

Recall that granules shield the asphalt from sunlight, reflect heat, add color, and provide fire resistance. About one-third of the weight of composition shingles is granules. Thus, for a 210 pound composition roof, there are about 70 pounds of granules per square, or more than a ton of granules on a thirty-square roof.

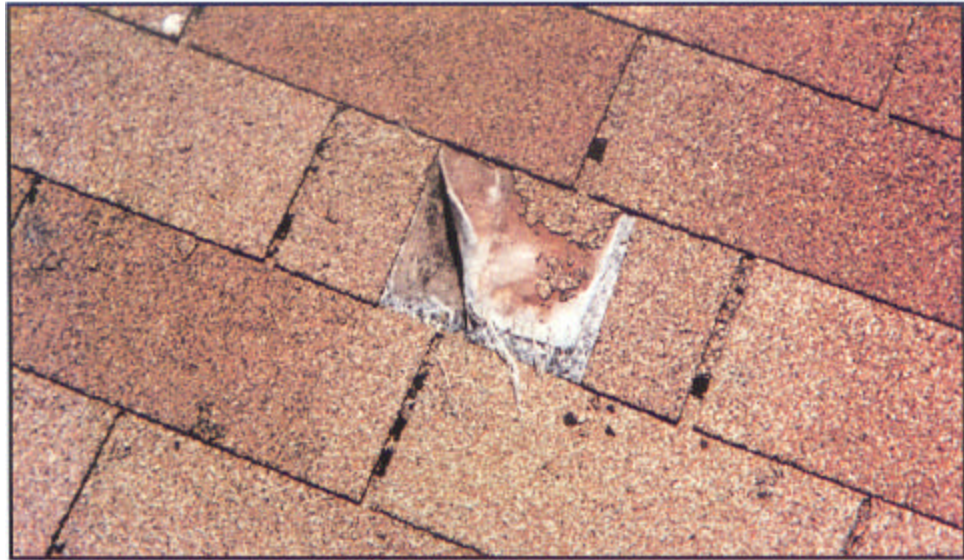
Photo 2.2.1 At the beginning of the manufacturing process, jumbo rolls of felt on reels are unwound into a dry looper (or accumulator) before application of the coating asphalt. When one reel empties and another is inserted, the felts are spliced. The splice region of felt is dissimilar to other areas and inherently weak as well. Therefore, a composition product containing a splice should be discarded (culled), never installed on a roof. This photo illustrates rapid deterioration typical of composition shingles which included a splice.

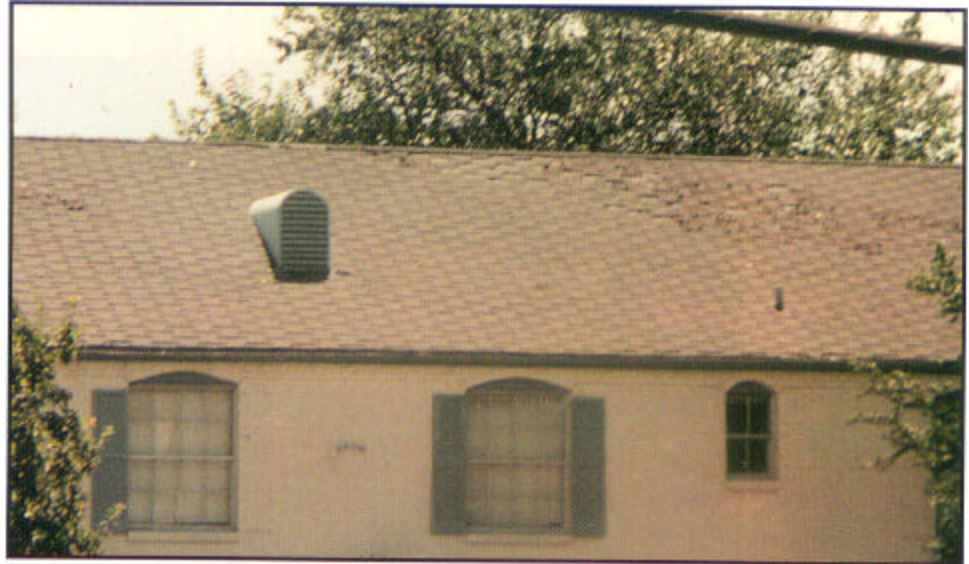
Photo 2.2.4 Another manufacturing defect. The repeated appearance of some unique shingle condition in a diagonal pattern on a roof, the result of standard application techniques, is definitive evidence of a manufacturing problem.

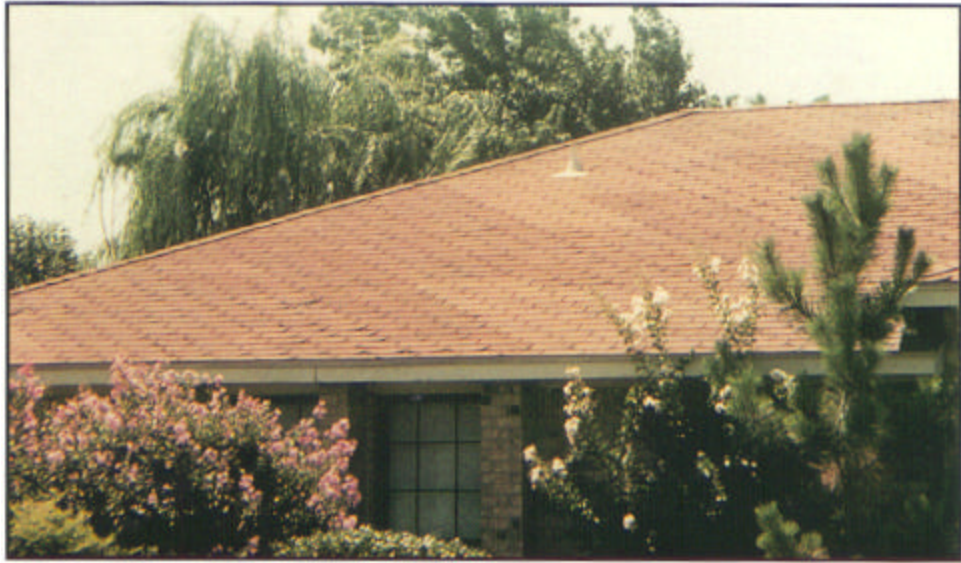
Photo 2.2.5 Different batches of shingles are likely to have slightly different colors. Color differences are known as shading and, likewise, tend to appear in diagonal patterns on a roof.

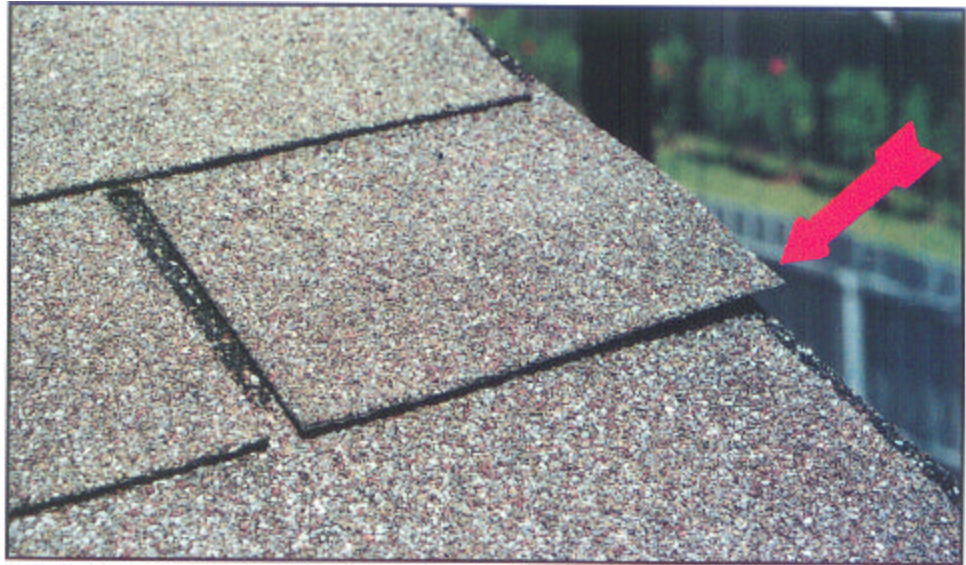
Photo 2.3.1 Nails and staples will migrate out of wood subjected to wet and dry cycles. Here we have a case in which a shingle has been buckled away from the roof by a withdrawn nail below. This problem also occurs if the fastener was not driven in flush when installed.

Photo 2.3.2 Close-up of the protruding nail beneath the shingle tab of Photo 2.3.1

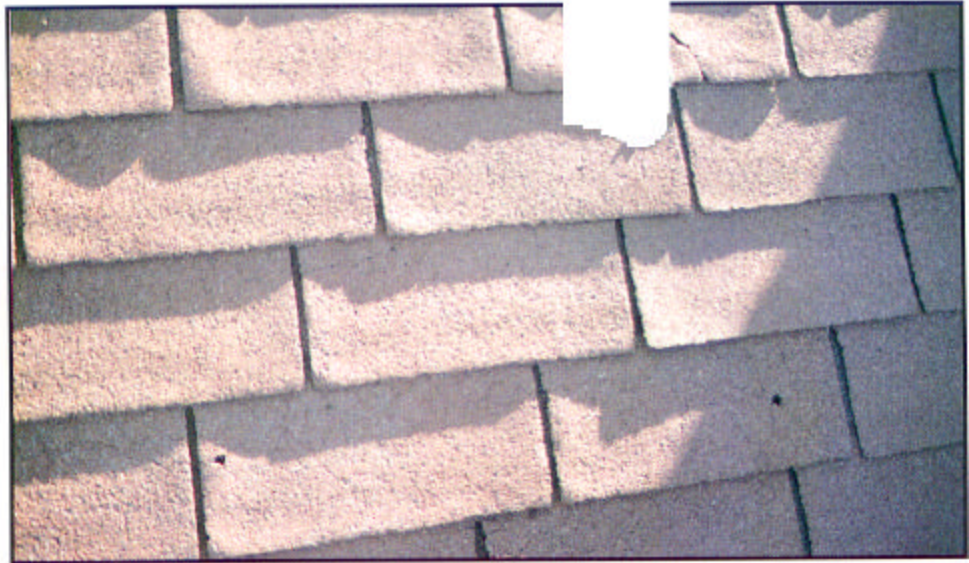
Photo 2.3.3 View of a weathered roof with holes in tabs caused by raised nail heads from below.

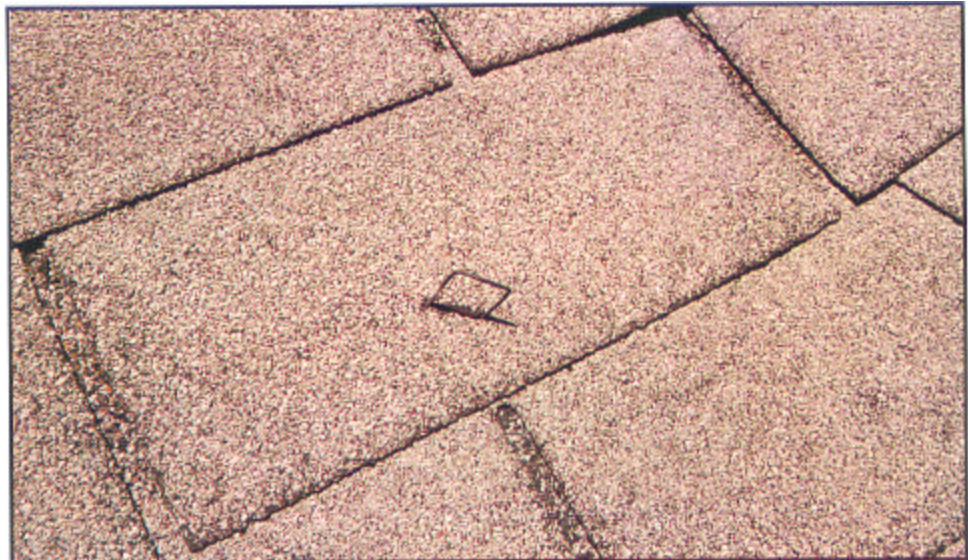
Photo 2.3.4 Shown here is a staple that has migrated through a tab from below. It has been our experience that shingles fastened with staples more frequently exhibit problems than those fastened with nails. Roofing nails are preferred over staples by the Asphalt Roofing Manufacturers Association (ARMA).

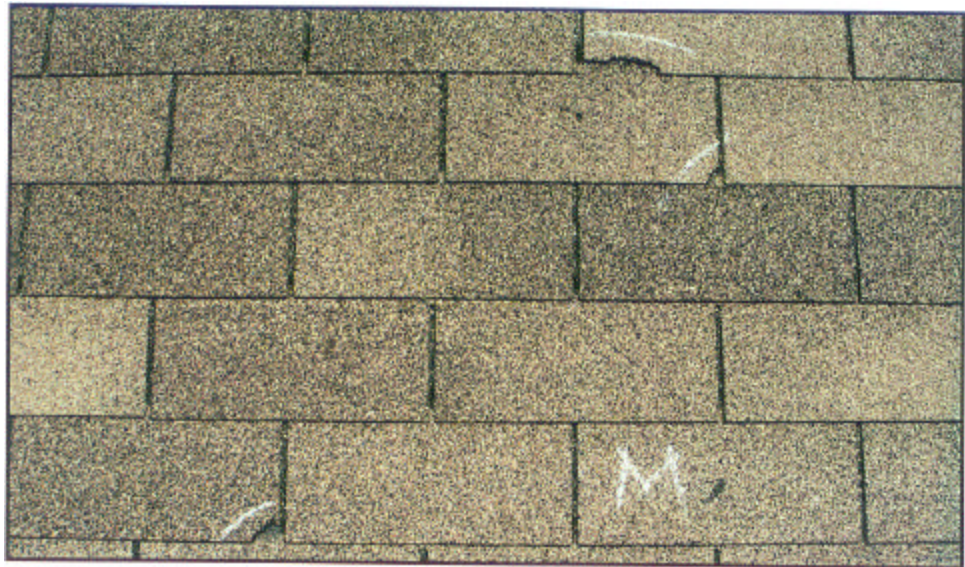
Photo 2.3.6 Several shingle corners had been torn away by mechanical action

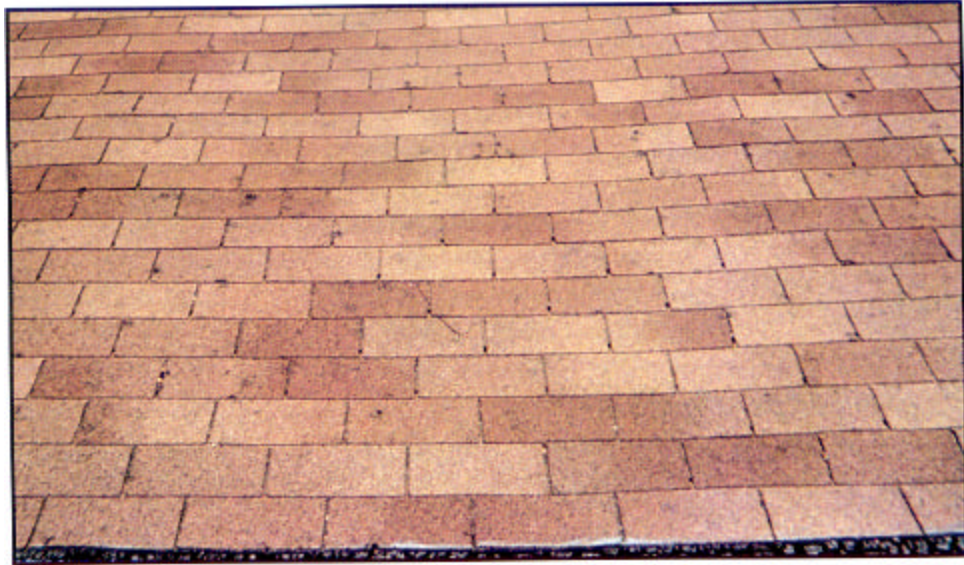
Photo 2.4.1 Overview of a natural hailstone-impacted roof. Note the randomness and separation of the larger impact marks.

Photo 2.4.2 Close-up of Photo 2.4.1.

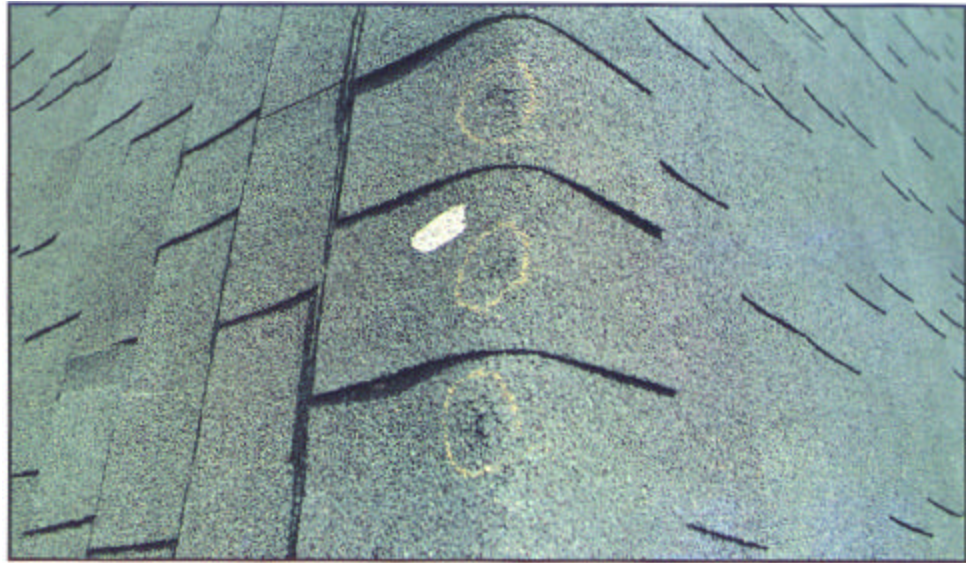
Photo 2.4.5 Close-up of bruises in ridge shingles caused by hailstone impacts.

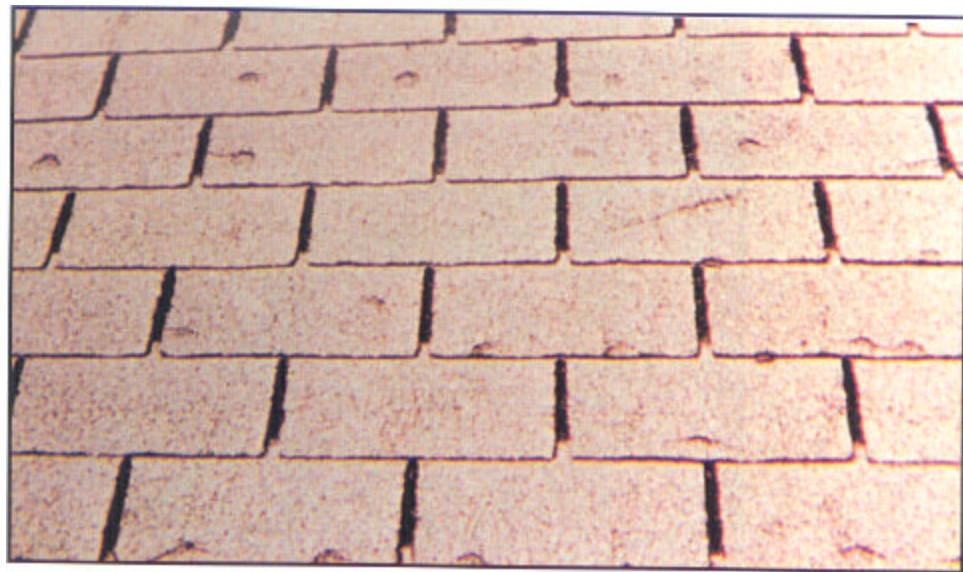
Photo 2.4.8 A composition roof impacted by "man-made hail." Note the regular distribution of identically sized marks.

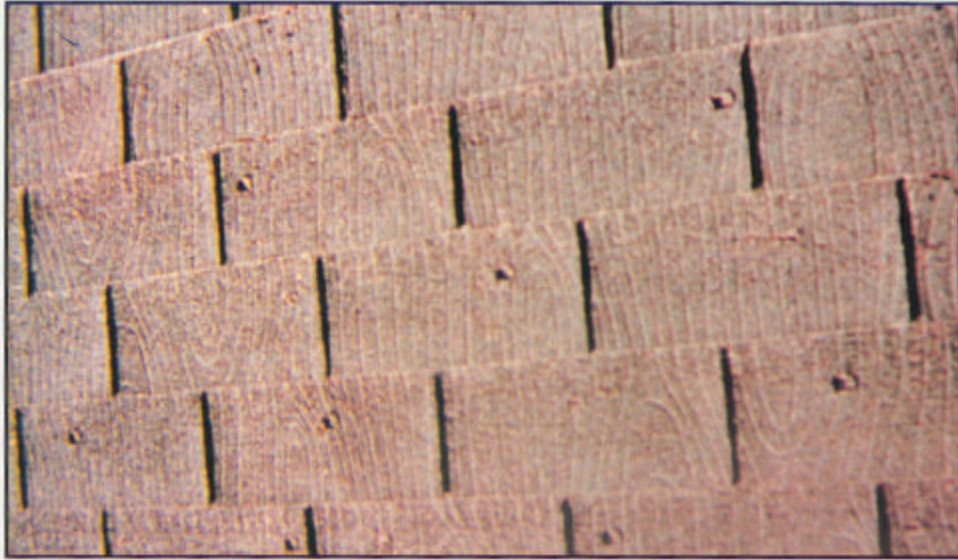
Photo 2.4.9 A roof impacted by “artificial hail,” perhaps the screwdriver variety.

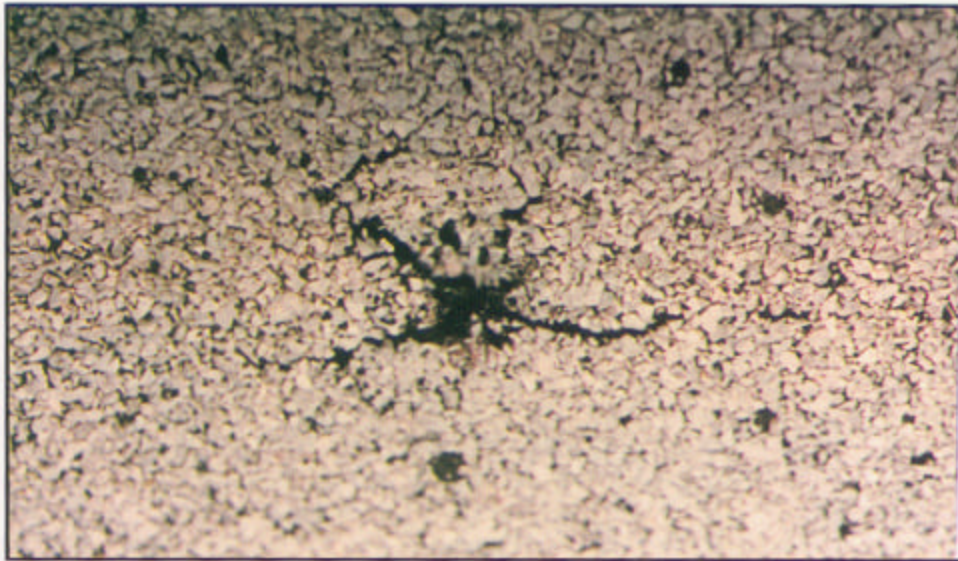
Photo 2.4.10 Close-up of a star-like impact mark caused by a hammer blow.

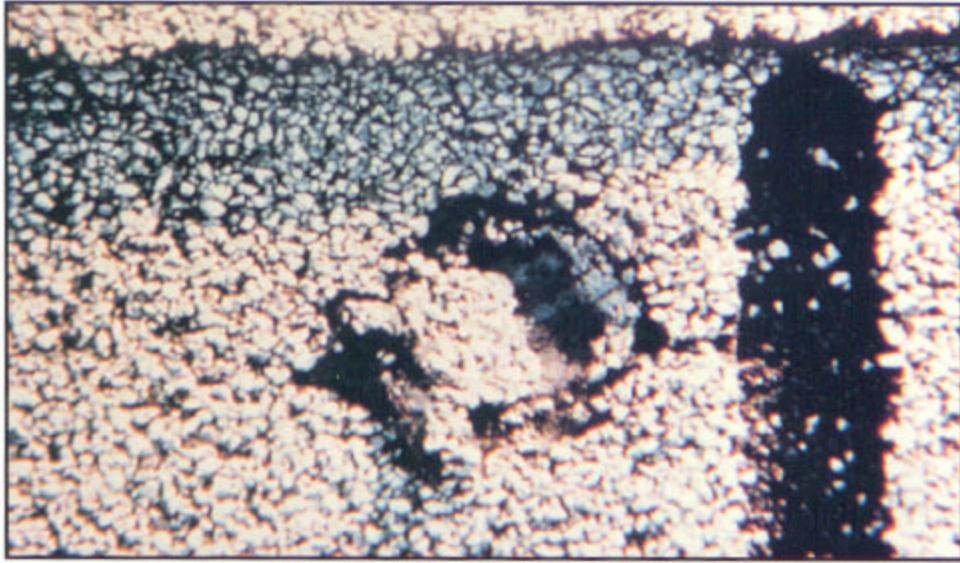
Photo 2.4.11 Close-up of a hammer impact mark on a composition roof. Note that the granules have been crushed at the point of impact; granules cannot be crushed by naturally occurring hail.
